GEOLOGICAL HAZARDS ASSESSMENT- NEW LOT 126

Date: May 7, 2009

GEOLOGICAL HAZARDS ASSESSMENT: LOT 127

GEOLOGICAL HAZARDS ASSESSMENT: NEW LOT 128

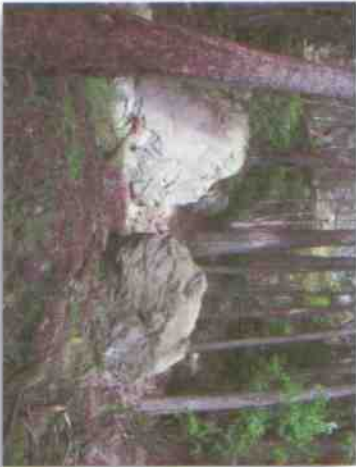
North

General Comments: Site located in a small gully at the base of a steep slope with evidence of rockfall. Mitigative measures may be required.

Hazard Type(s): Rockfall potential Low

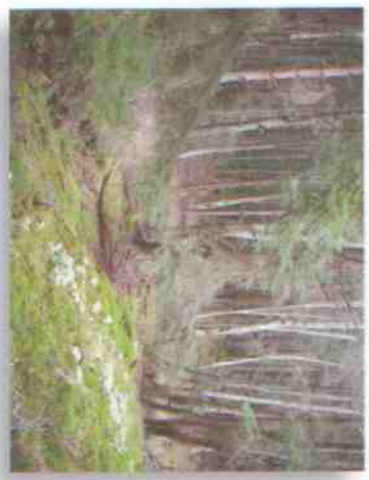
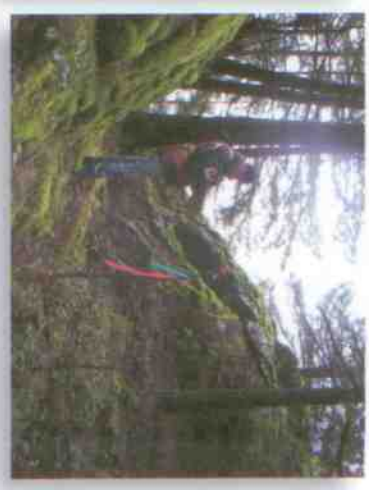
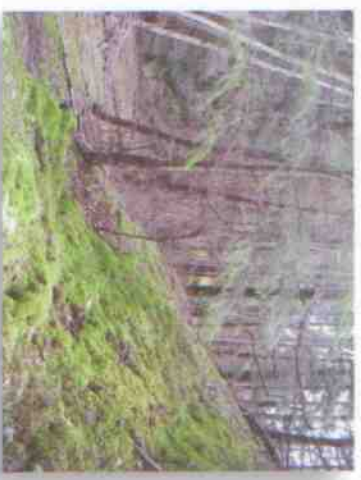
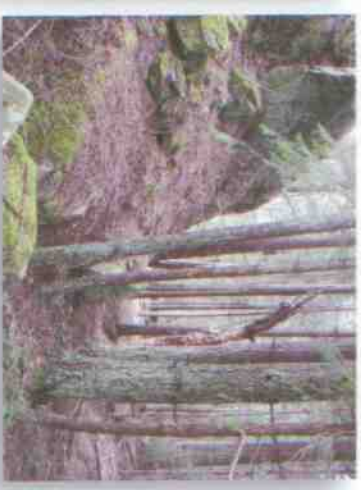
General Comments: Located between 2 bedrock ridges. Large boulders have fallen from west ridge, but not in area of building site.

Hazard Type(s): Rockfall to west of building site, but not serious enough to endanger potential home on site.

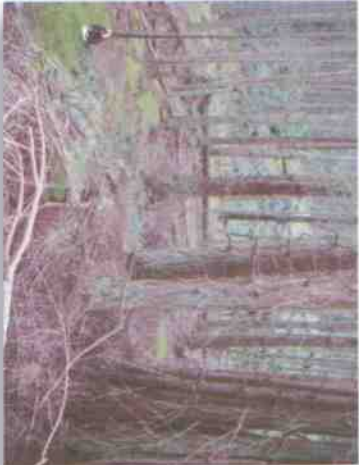
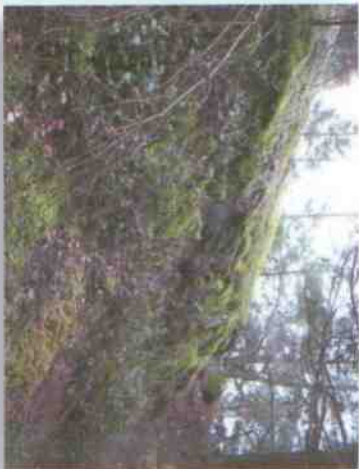
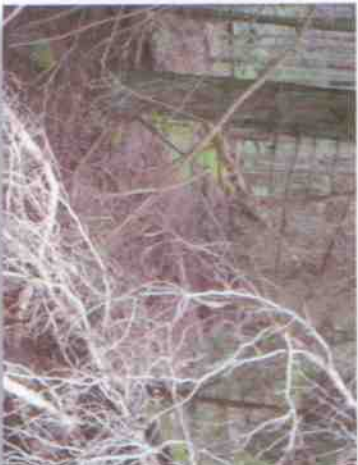
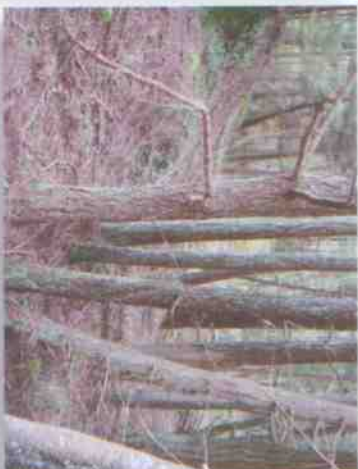
General Comment: Site is located on a narrow bedrock ledge adjacent to a bedrock ridge with steep slopes on all sides.

Hazard Type(s): No hazards observed

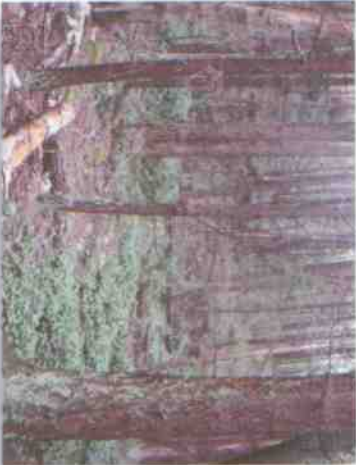
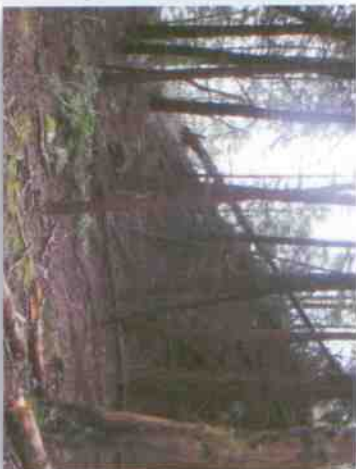
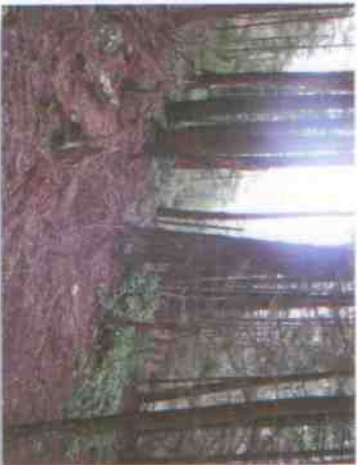
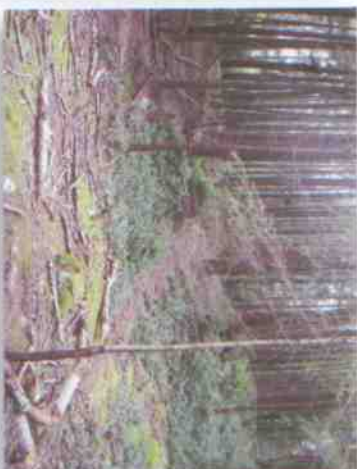
General Comments: This is a flat area with bedrock slopes surrounding the building site location.

Hazard Type(s): No observable hazards

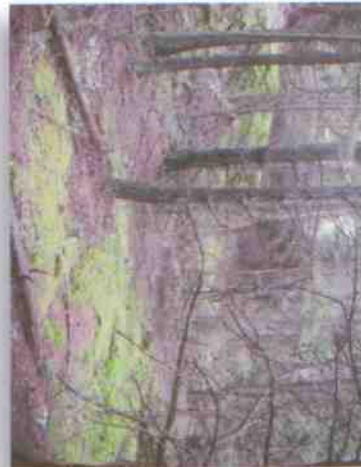
North

General Comments: In swale below bedrock ridge. High slope (>20 m high) to north. No recent rockfall observed.

Hazard Type(s): No observable hazards within proposed building site. Potential rockfall from slope to north (20 m to slope base).

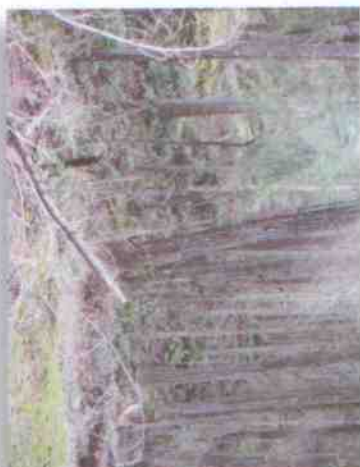
North

General Comments: Top of bedrock ridge with a steep (near vertical) slope to the south and steep slope to the west.

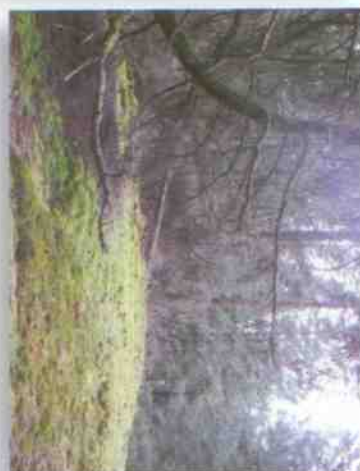
South

Hazard Type(s): Potential slope hazards (rockfall/rockslide) to south.
Build within proposed building site area.

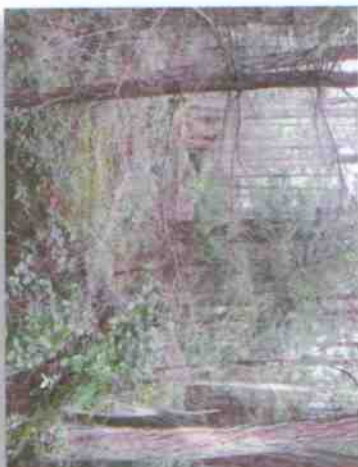
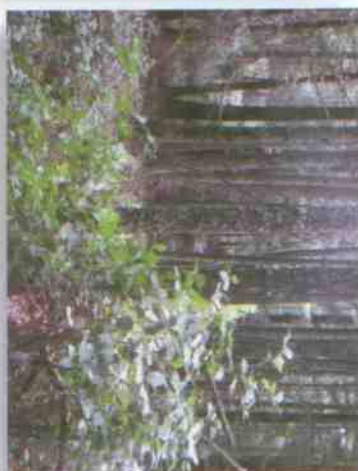
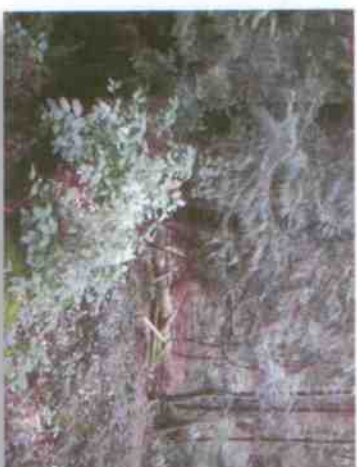
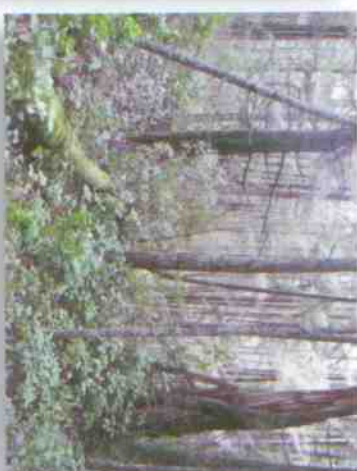
General Comments: Generally flat with some undulations. Veneer of soil over bedrock.

Hazard Type(s): No observable hazards

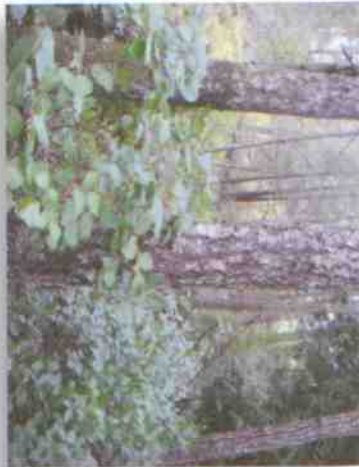
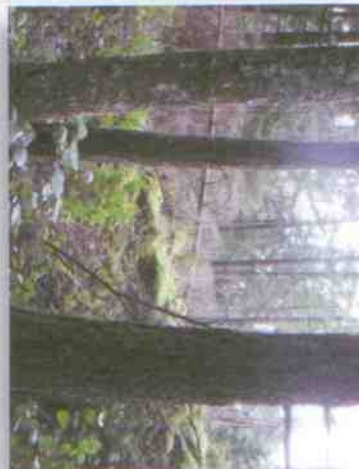
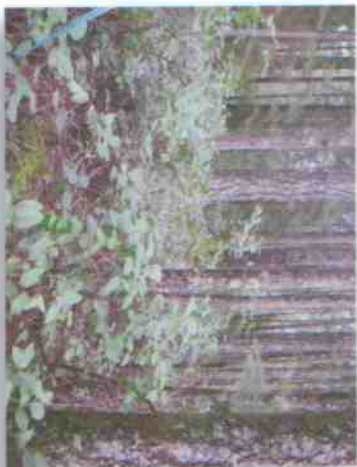
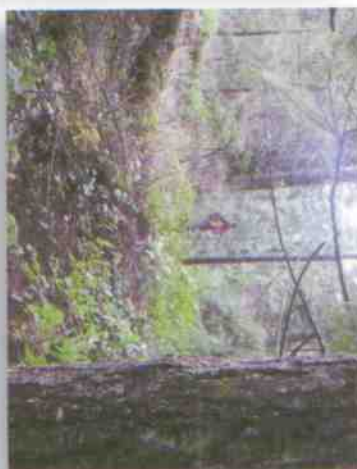
General Comments: Flat bedrock shelf which rises to the north.
Bedrock outcrop to south

Hazard Type(s): No observable hazards

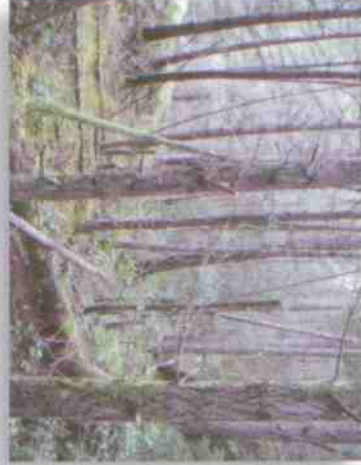
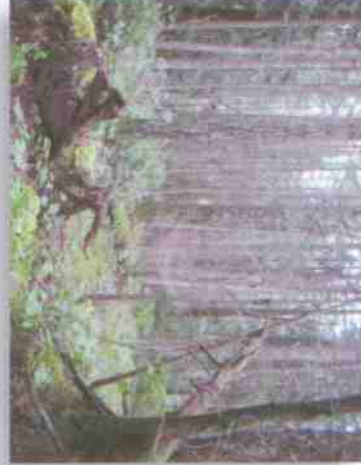
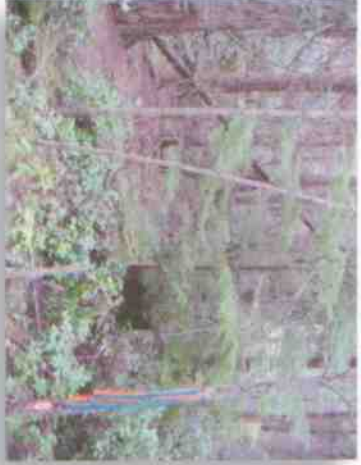
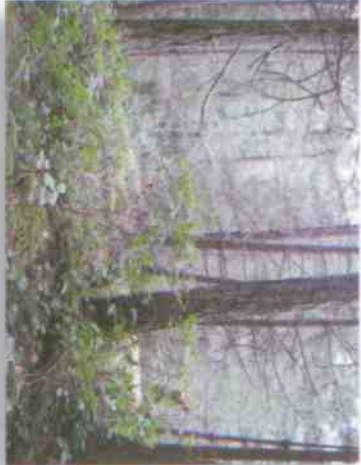
General Comments: Located on a flat area on bedrock ridge (steep slope to north). Slopes to east and west.

Hazard Type(s): No observable hazards

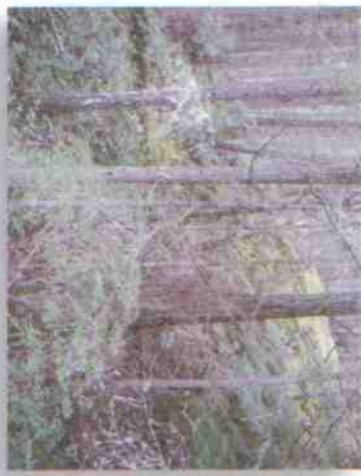
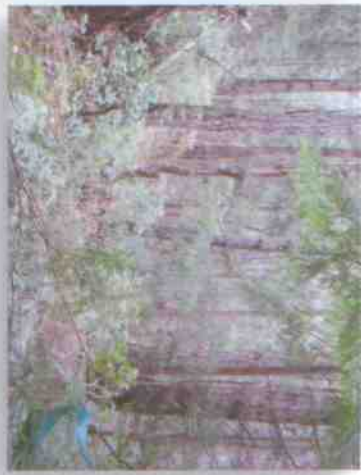
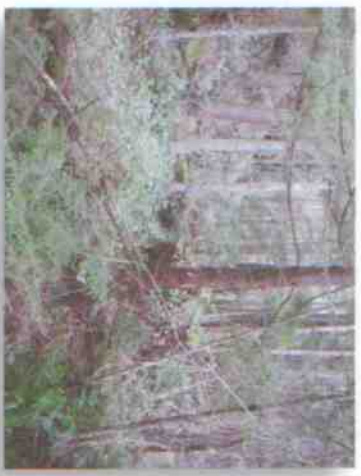
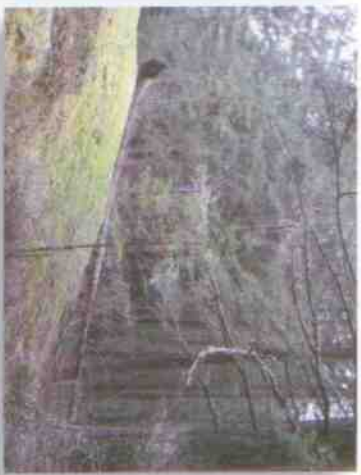
General Comments: Located on a bedrock ridge (steep slope to north).

Hazard Type(s): No observable hazards

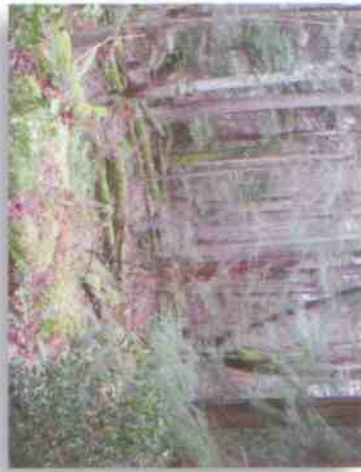
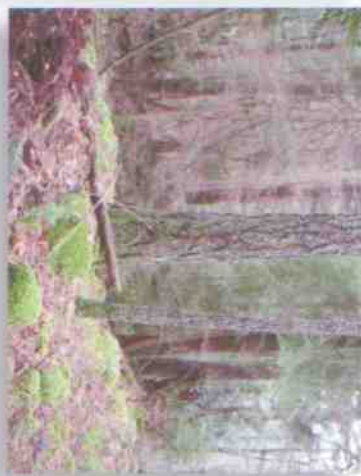
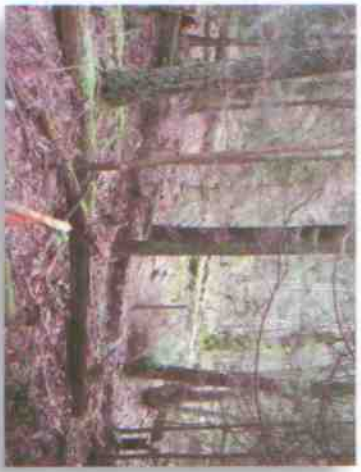
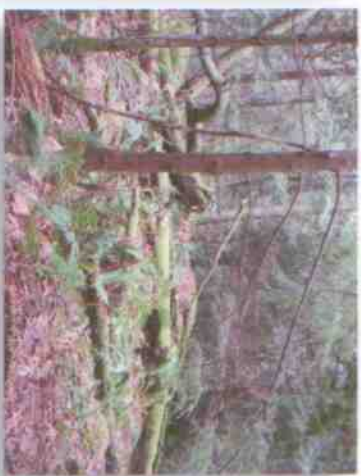
General Comments: Building site is relatively flat with thin soil veneer over bedrock. Slopes down to south.

Hazard Type(s): No observable hazards

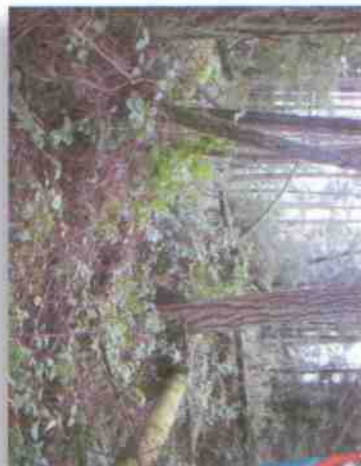
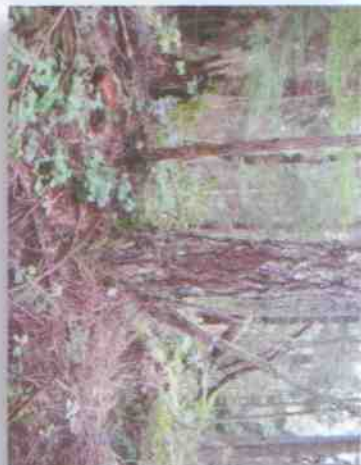
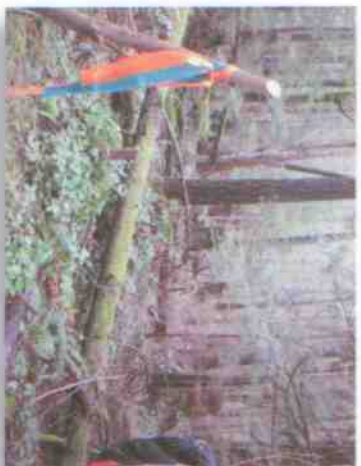
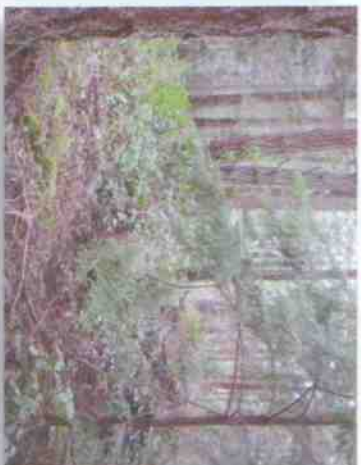
General Comments: Building site is relatively flat with thin soil veneer over bedrock.

Hazard Type(s): No observable hazards

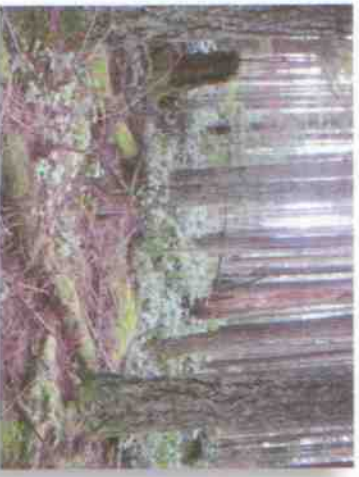
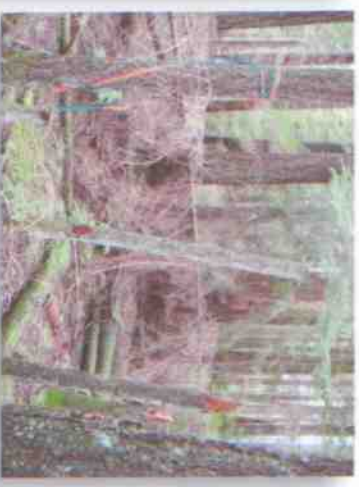
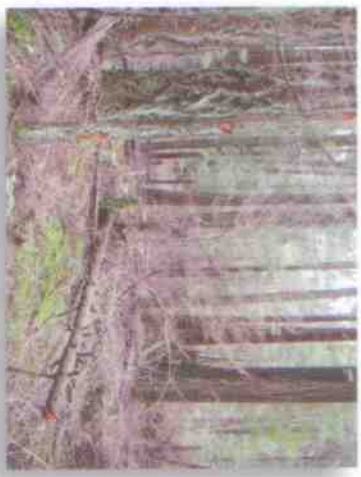
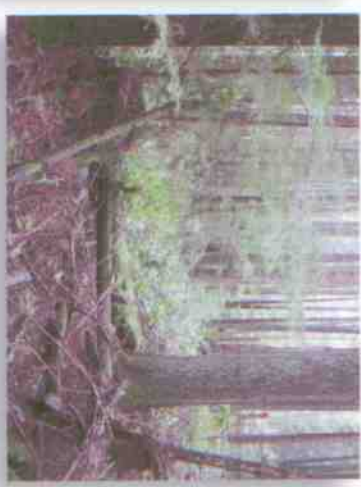
General Comments: Building site is relatively flat with thin soil veneer over bedrock.

Hazard Type(s): No observable hazards

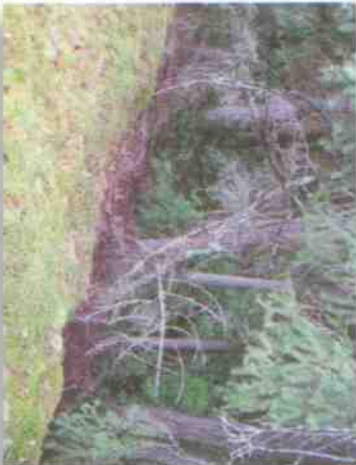
North

General Comments: Site located on bedrock knob with steep drop to the north, slope

Increases with distance to East, South and West.

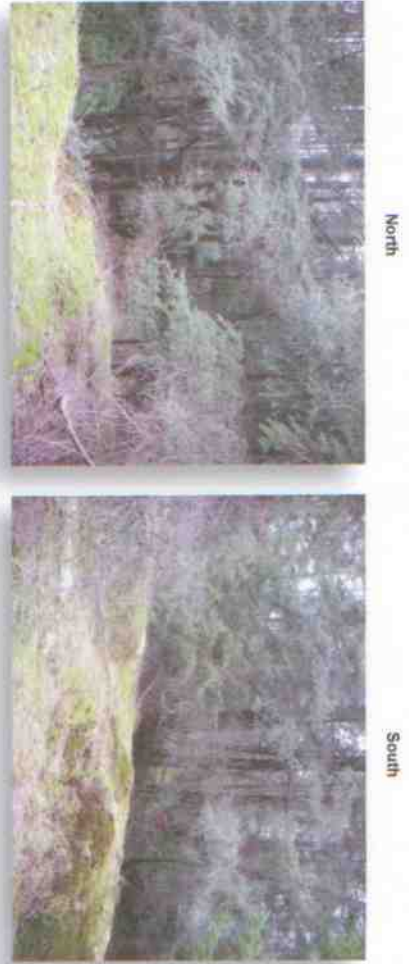
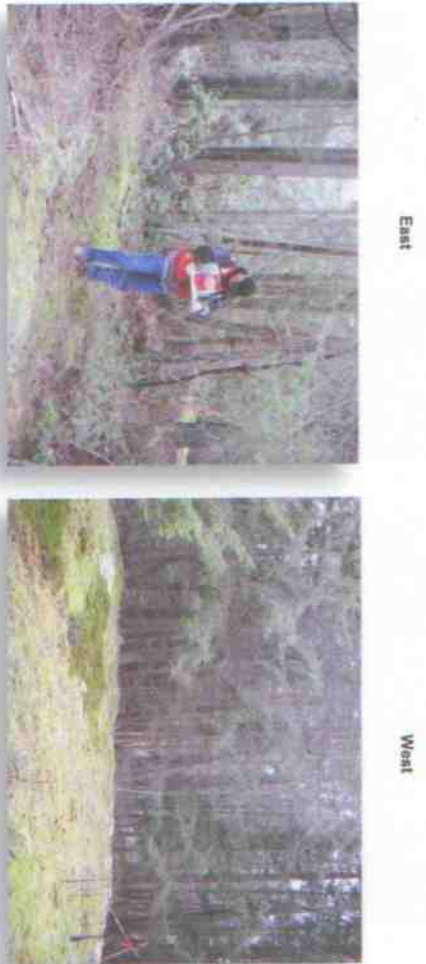
General Comments: Bedrock outcrop on top of bedrock ridge. Steep slopes away from building site in all directions. Proposed building site okay

Hazard Type(s): No observable hazards

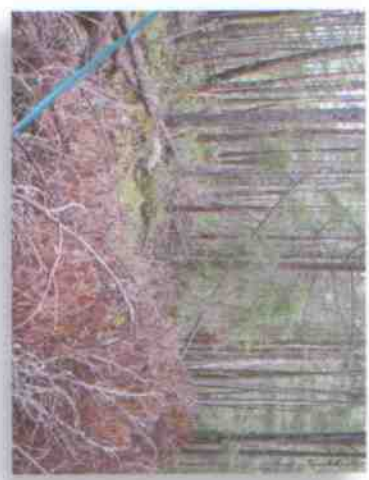
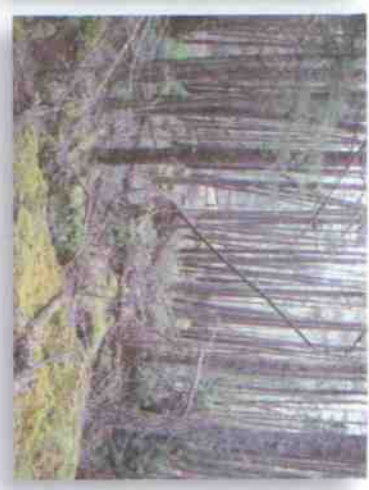
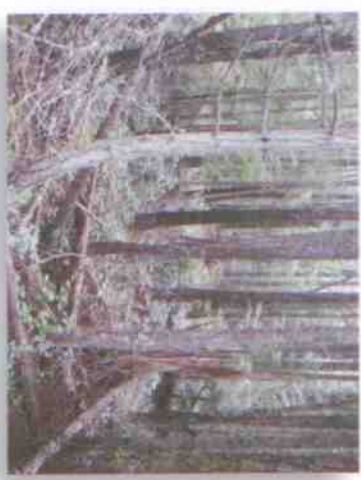
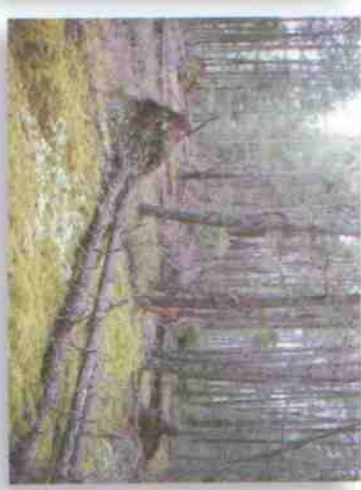
General Comments: Building site on bedrock ridge which slopes down in all directions. Thin veneer of soil over bedrock.

Hazard Type(s): No observable hazards

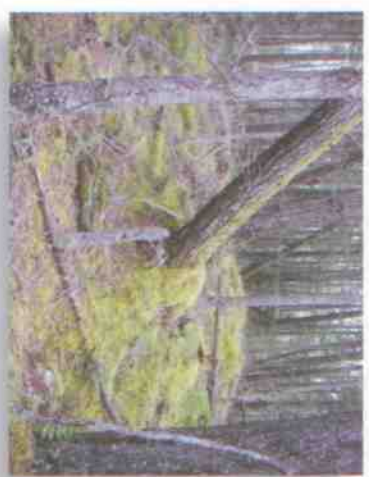
North

General Comments: Building site on bedrock ridge with near vertical bluff to southeast, south and southwest. Flat area to north and west.
